VI. ARCHITECTURAL ANALYSIS

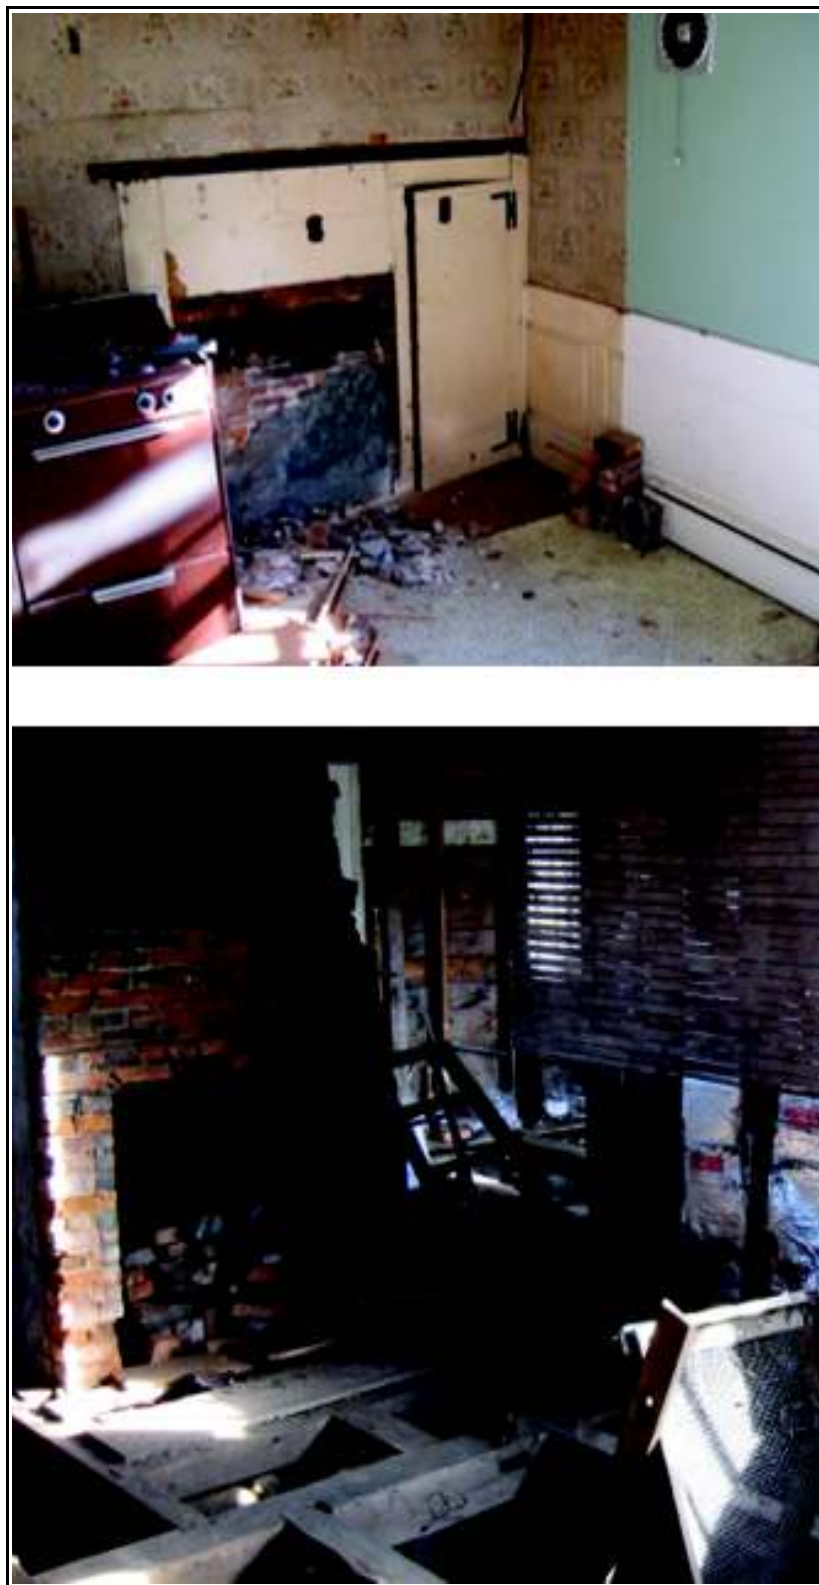
Figure 22. Center Ell hearth before and after renovation stripping

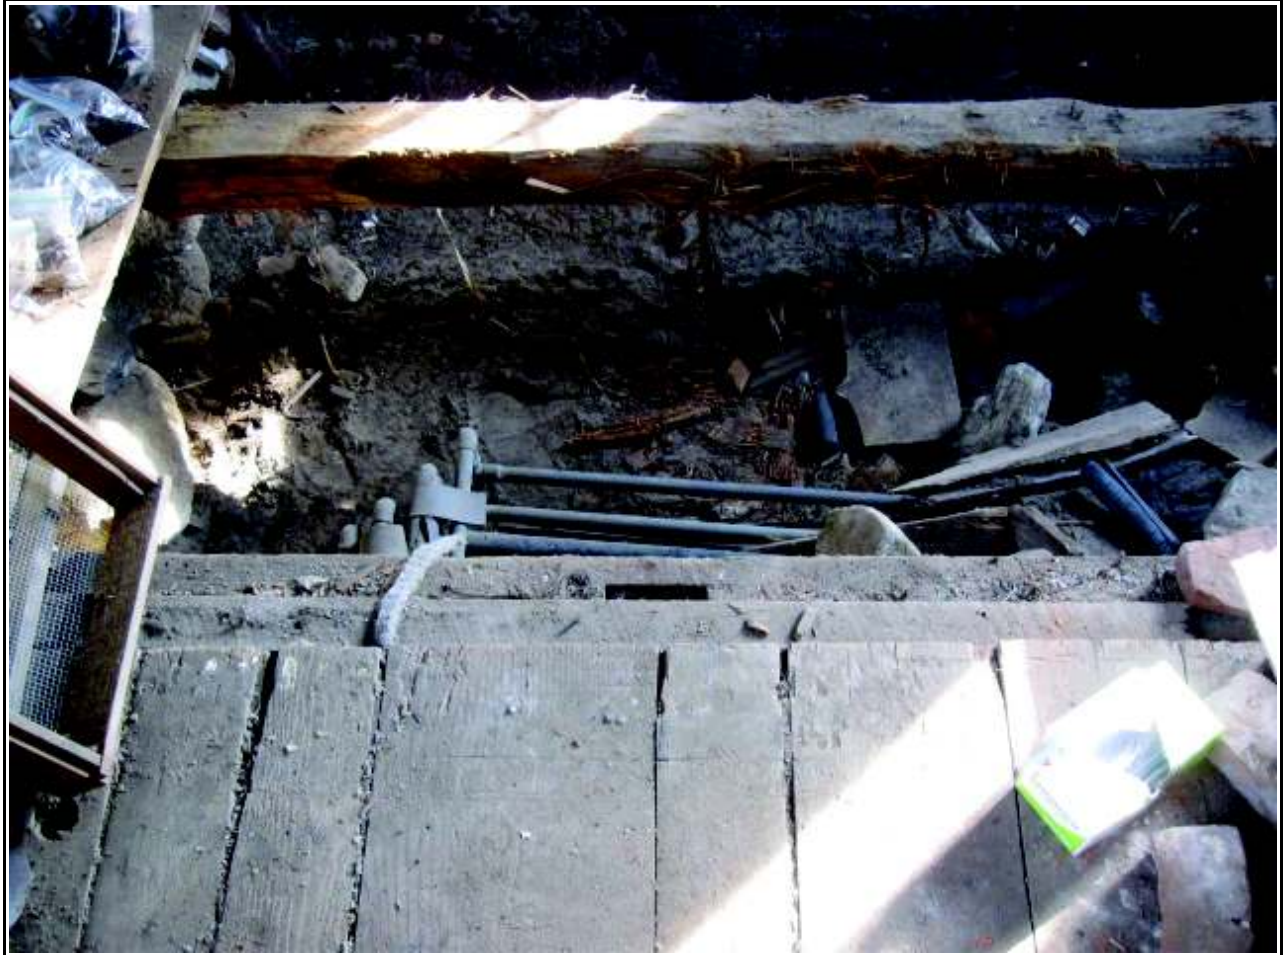
Figure 23. Bark covered floor joists in the North Ell

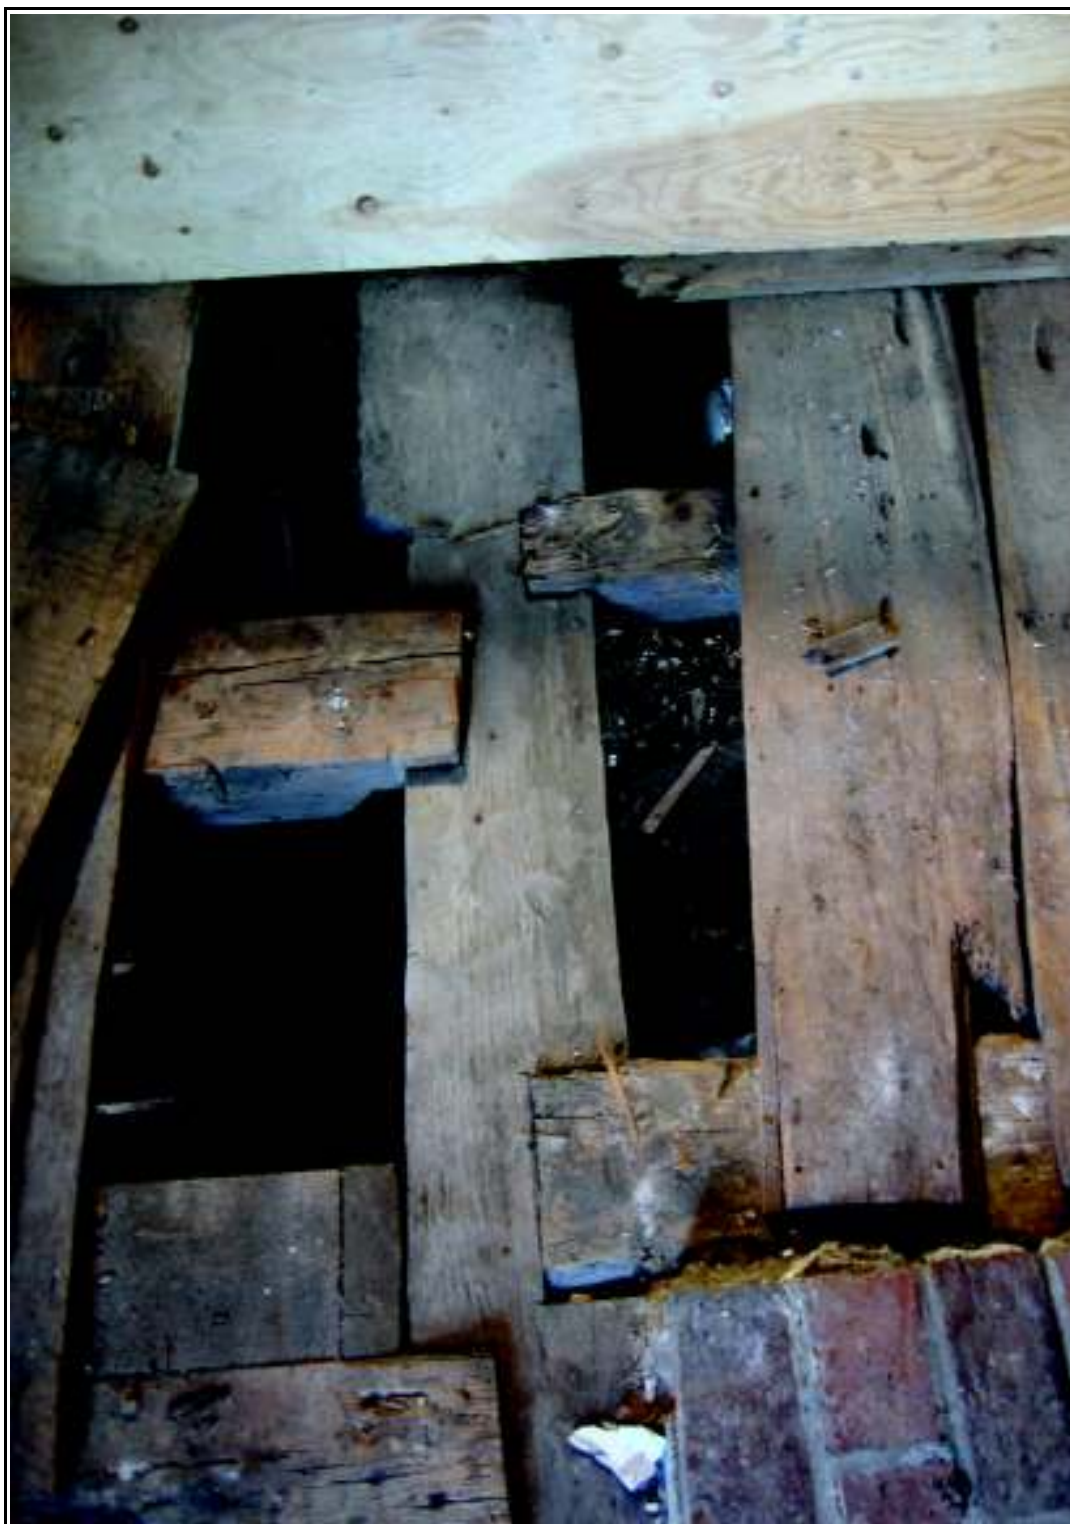
Figure 24. Seventeenth century architectural elements

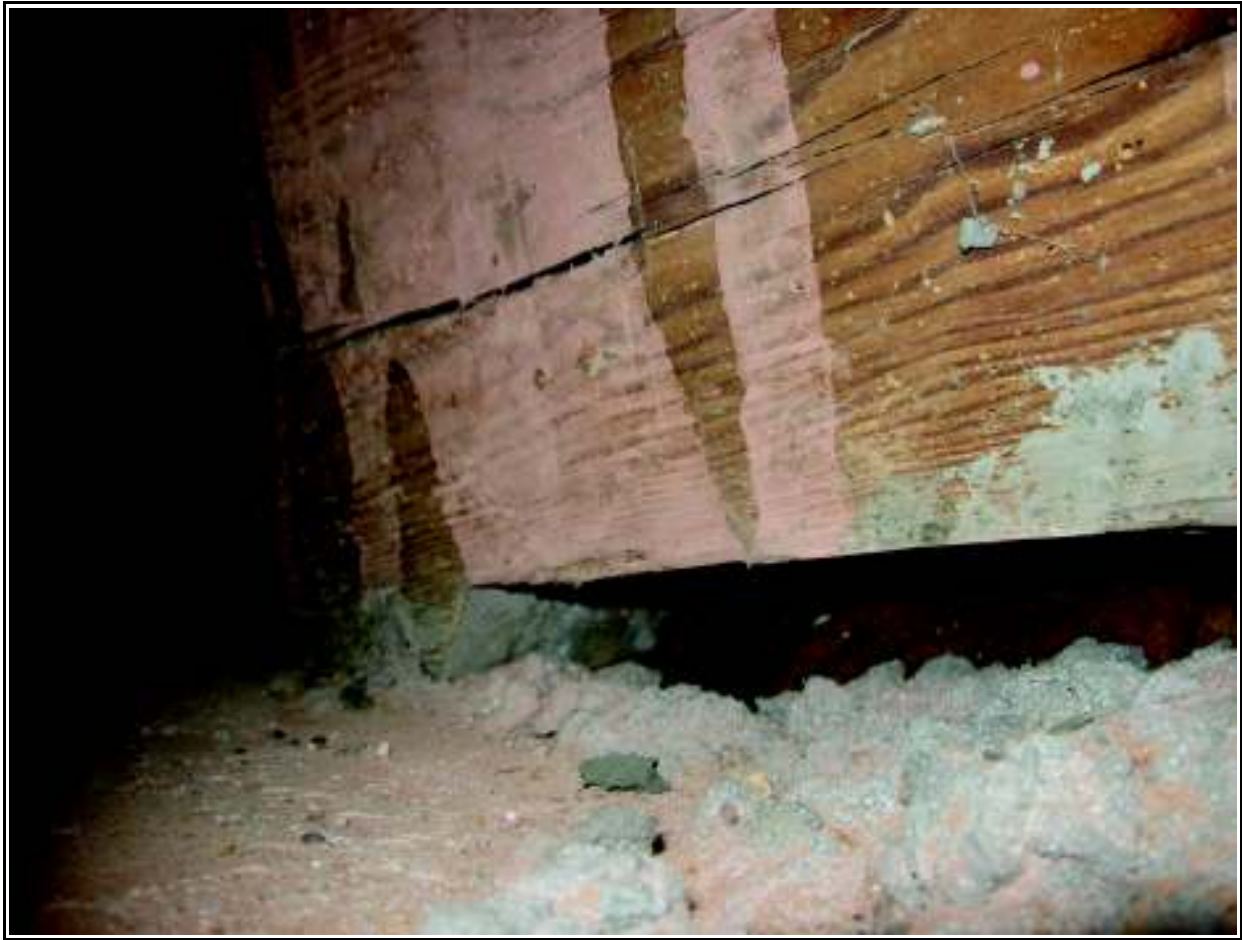
Figure 26. Gunstock post in parlor

Figure 25 shows the timbers discussed in the following section. Beginning in the parlor, a gunstock post was found directly south of the fireplace (**Figures 26 and 27**). The gunstock portion of the post now faces down but a large pocket for the seating of the second story clamp is present on the same side as the gunstock. This indicates that the house that it came from was two stories tall. The pocket is 11" long and 2" wide. Whitewash is present on the lower half of the post indicating that the lower story of the house was whitewashed but the upper chamber was not. The floor joists in the parlor are of pitch pine and probably were created by Samuel Taylor and are not reused. They have been bored out with spoon bit from a rat-tail auger, a tool that was used well into the eighteenth century. They measure 8 3/4" x 8 1/2" squared. The sills in the parlor have two stud pockets on one of them, indicating a possible doorway located 14' 21/2" from the end of the sill and measuring 2'9" wide. This doorway would have been in the original house. The front sill possibly has an early pocket on it on the side of the beam flipped over. The beam is whitewashed and chambered possibly pitch pine. This sill may have originally been a top plate.

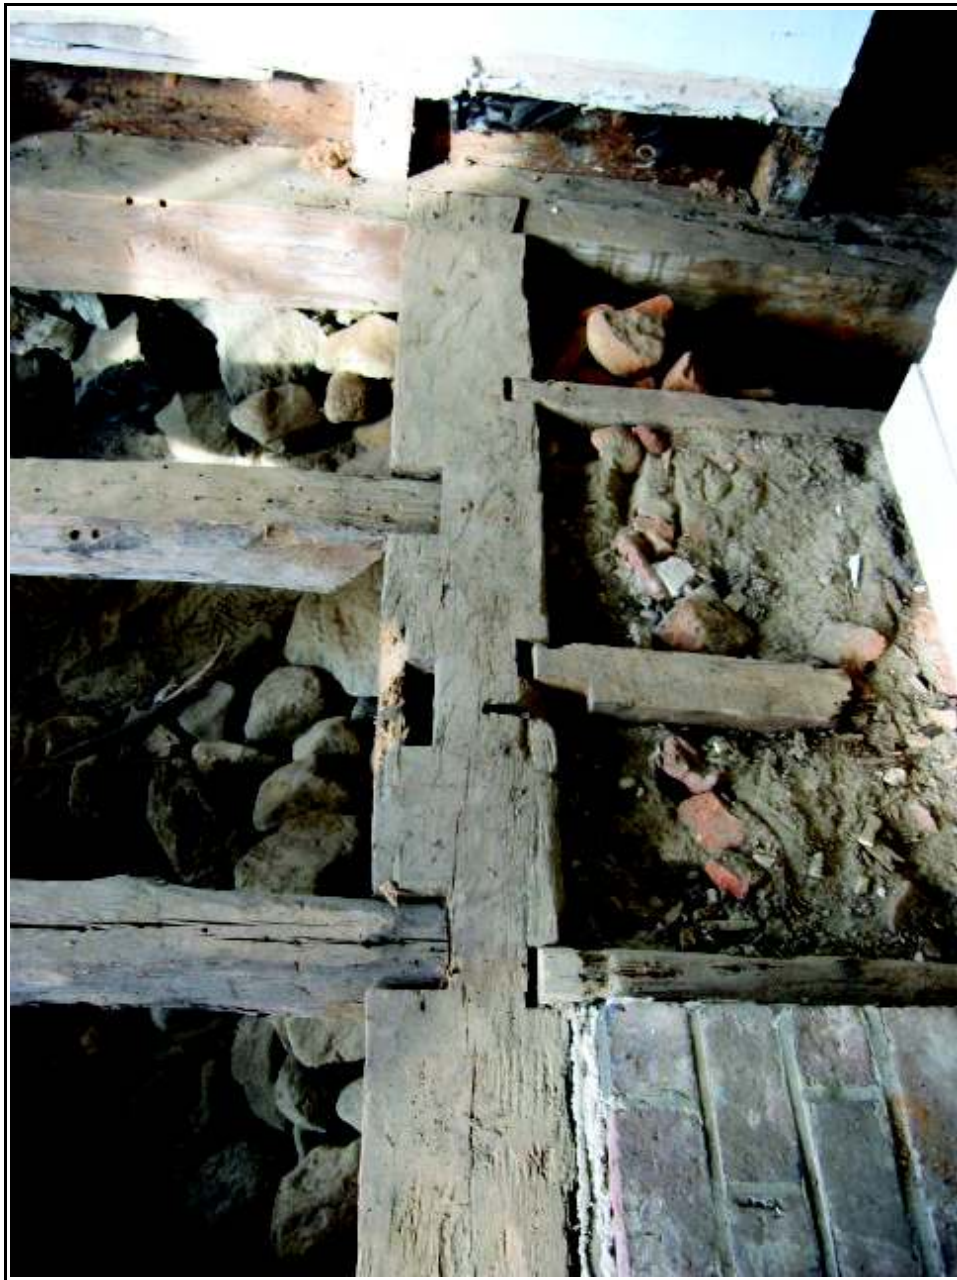
Figure 27. Location of Gunstock post in Parlor

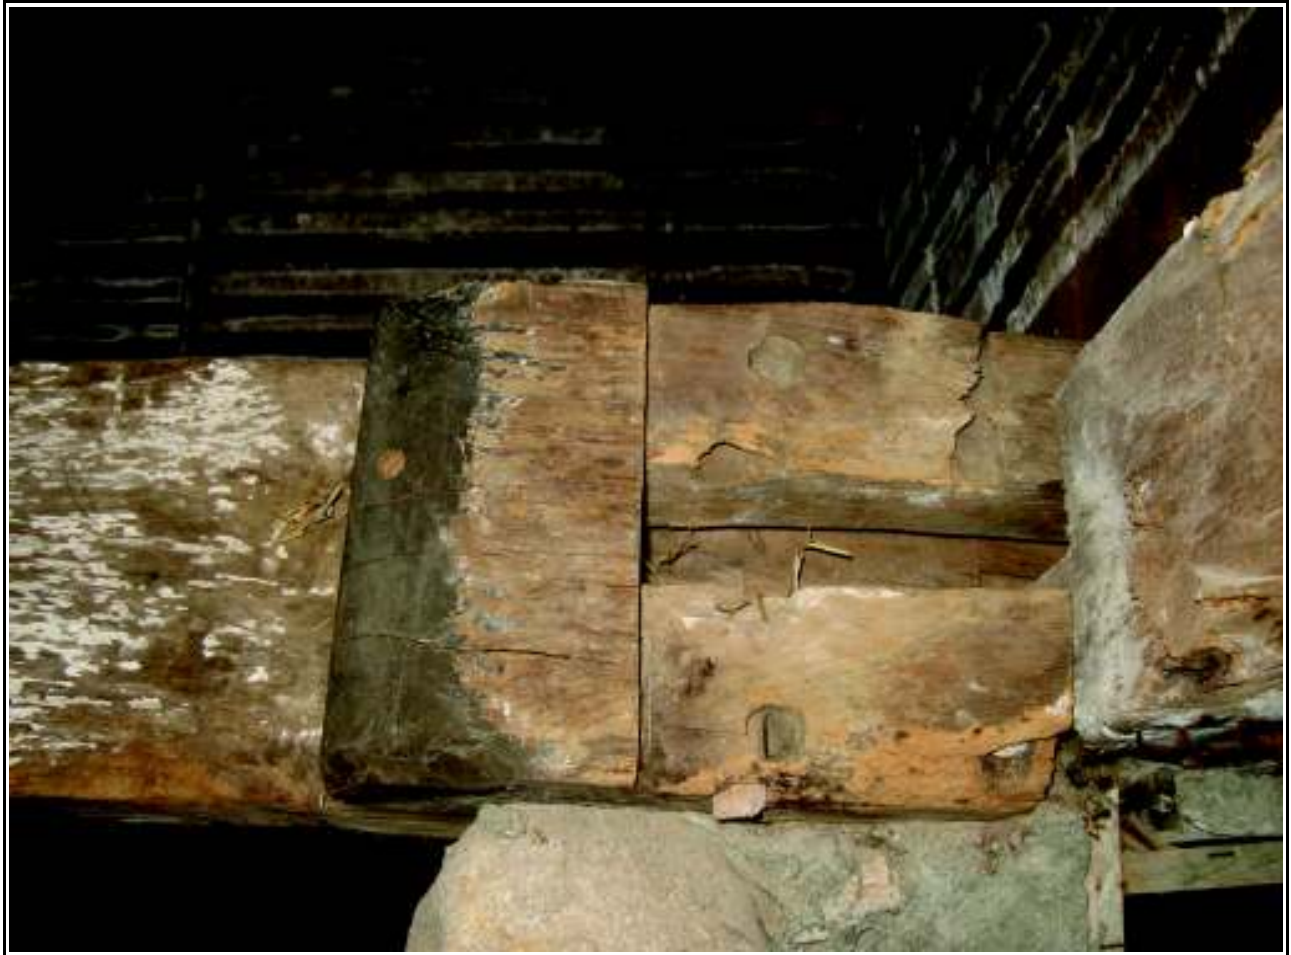
Figure 29. "Ship's Timber" in former bathroom used as joist

In the former bathroom was another gunstock post having been reused as a floor joist (**Figure 29**). This post has a brace hole that is 11" long with chamfering on the bottom ends of the brace. This beam measures 8 1/2" x 7'2". On the north side of the bathroom, the top plate appears to be a tie beam with a rising brace that may have possibly come from an outbuilding. Used as a floor joist is what has become known as the "ship timber". This beam bears a gunstock on one end and is relatively thin. This timber

as a II and a III inscribed on the back side and a black painted rounded gunstock with whitewash on the remainder of the timber. It is pit sawn with a 1 1/4- 1 3/8" wide complex mortise on the top. This beam was used to fasten a post to the tie-beam end to form the bents, and then to tie the bents by means of the front and back top plates to make the house frame. A very similar tie beam was identified in one corner of the 1670 Hawkins House in Connecticut. A second rafter runs between the pantry and the bathroom on the east wall. The purlin pockets on this rafter are 3" long.

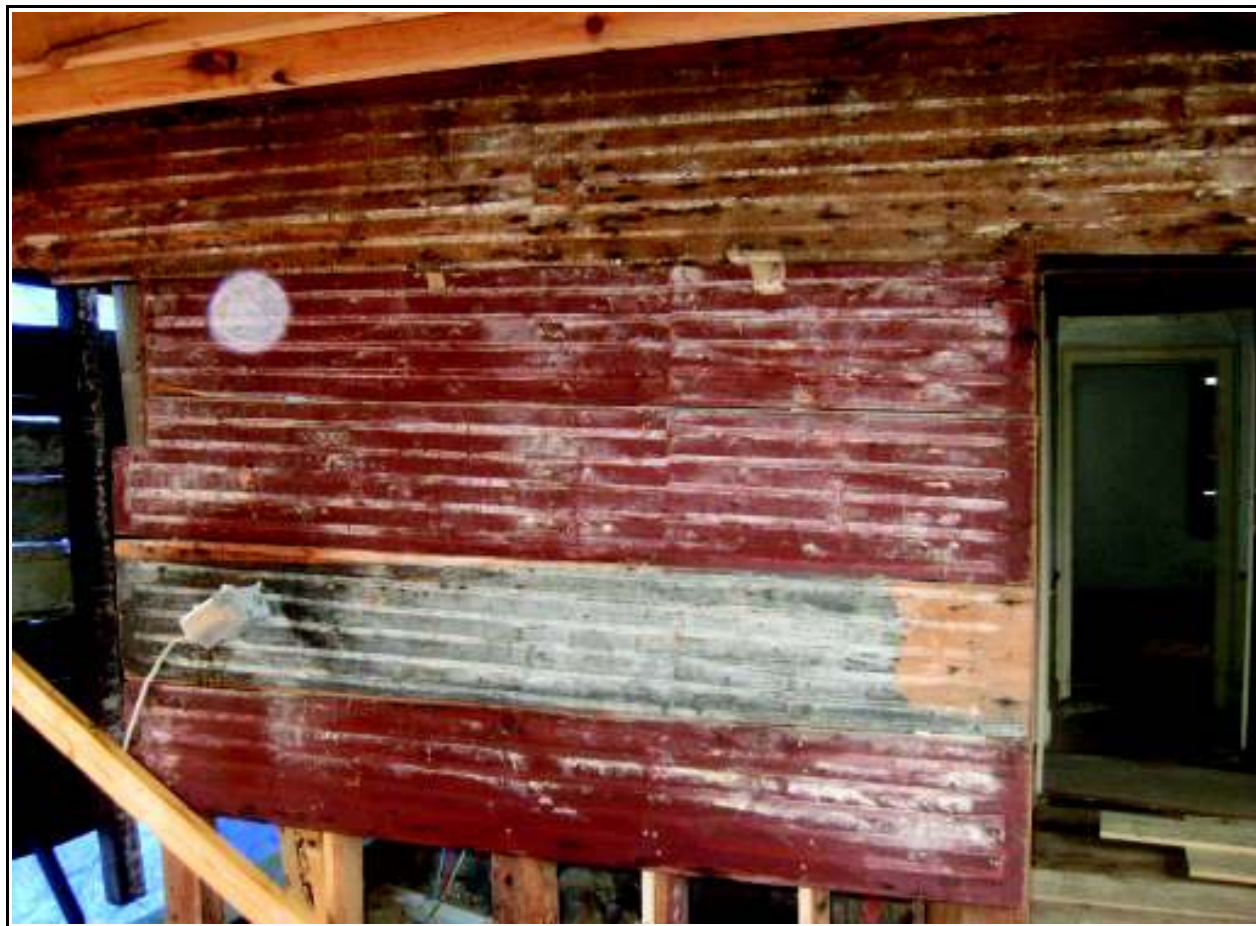
Figure 30. Red milk painted wainscotting boards on north side of Pantry

The sheathing boards in the pantry appear to be water sawn but may date from the seventeenth to eighteenth century. A top plate with a lug dovetail joint is present between the pantry and the kitchen. This beam is 17'5" long with a nice mortise on the top and a hole for the peg. This appears to be a mortise that would fit into the teasel tenon on a gunstock post. The exterior boards on the pantry are bead boards with nice beaded edges and red milk paint (**Figure 30**). They were originally used inside of the house, possibly in the parlor or hall. The board range from 25 to 29" wide. On the exterior of the house, once the shingles and tar paper were removed, several red milk painted boards were also identified.

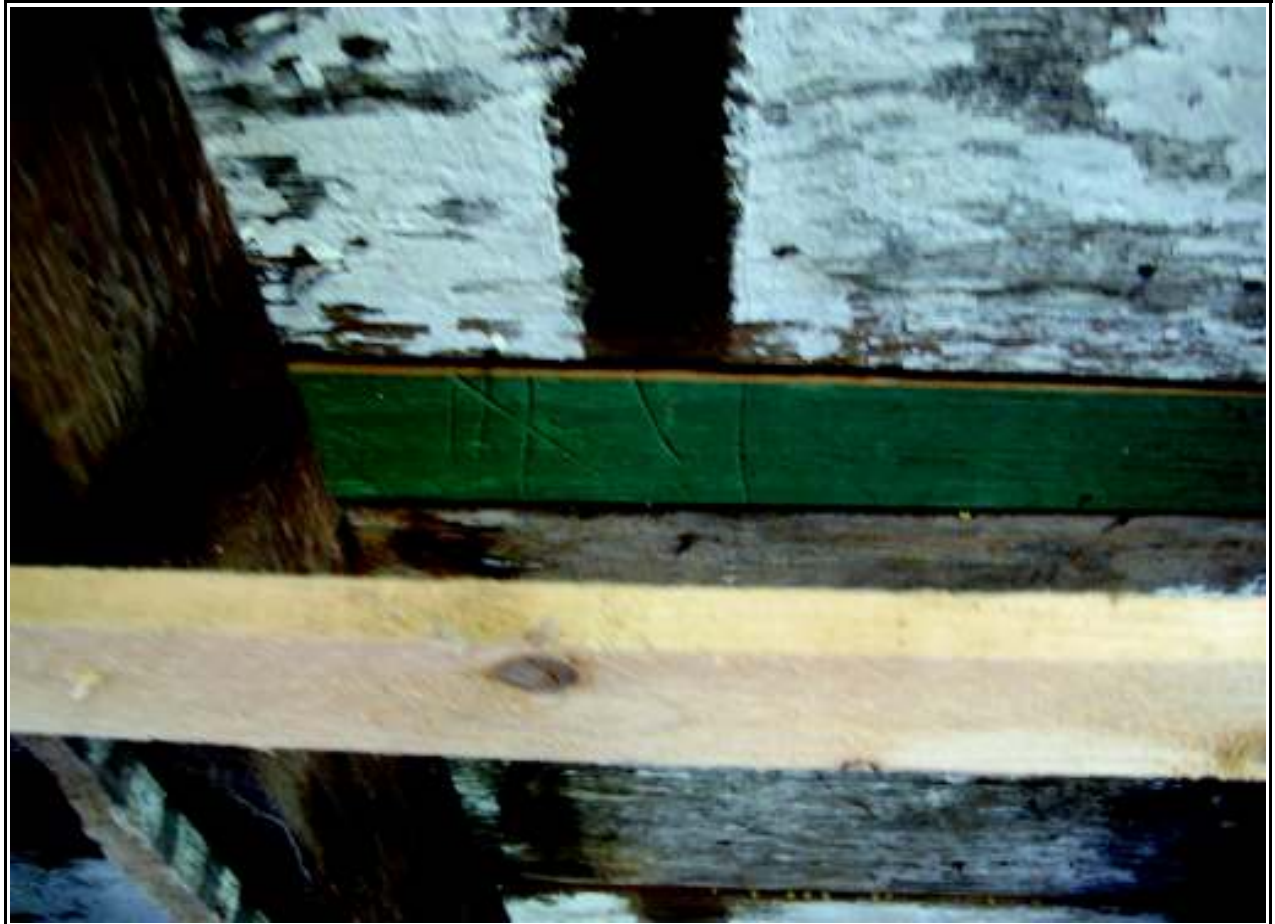
Figure 31. Whitewashed boards in attic

Several roof boards in the attic are whitewashed and bear ghost images of the joists (**Figure 31**), possibly those that are in the kitchen, on them. The roof rafters all appear to be more modern than the later eighteenth century.
